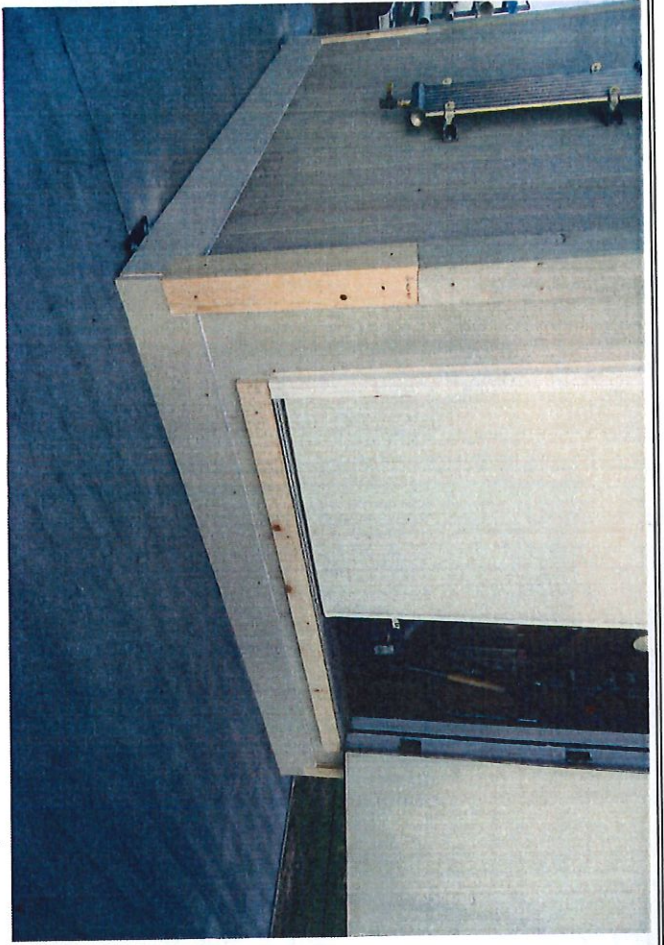
North and west sides of remediation building, showing replaced bottom trim and other replaced sections, including door jam.

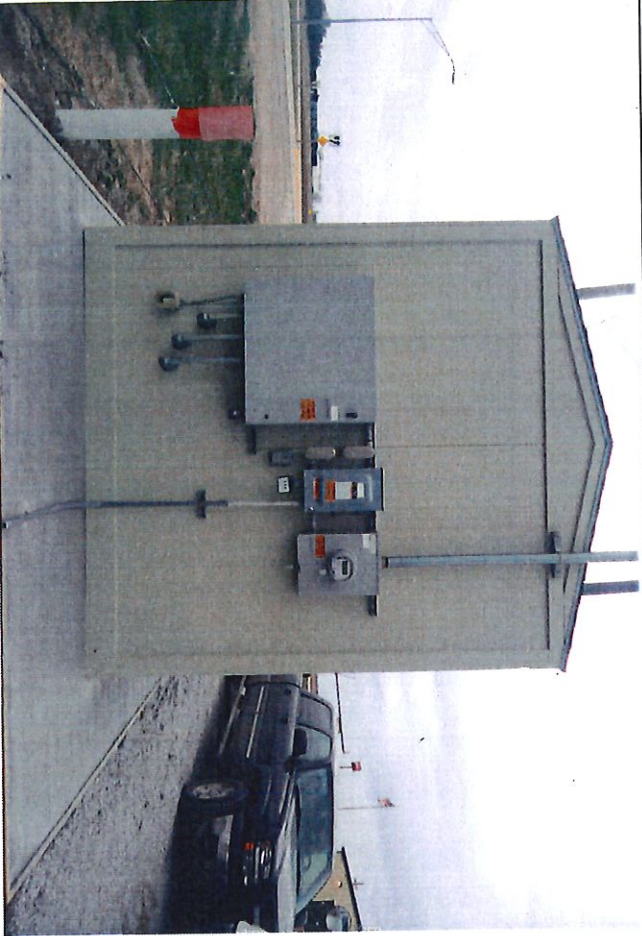
View of east side of remediation building after being re-painted.

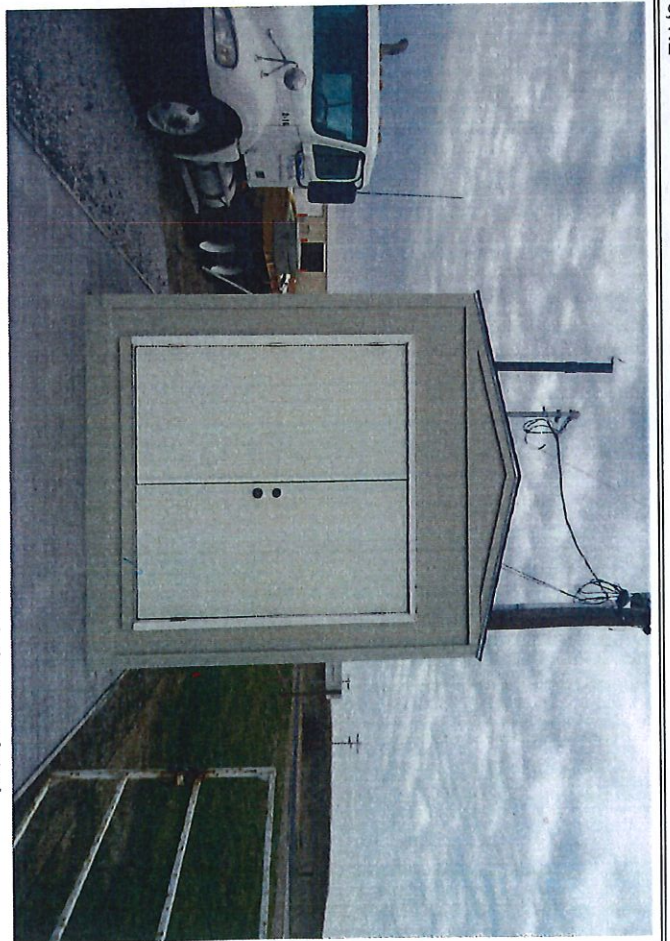
View of west side of remediation building after being re-painted.

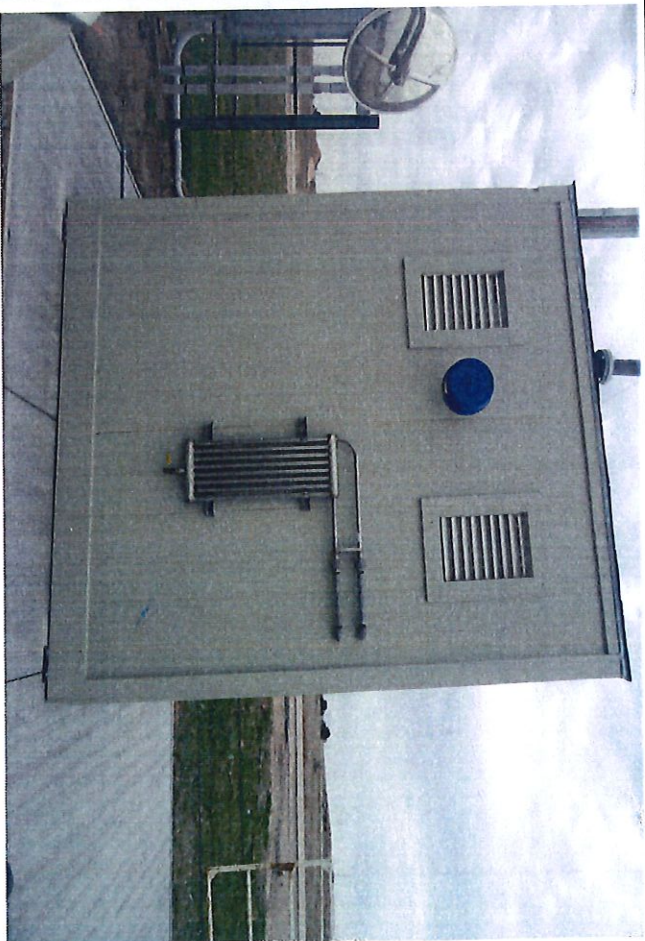
View of north side of remediation building after being re-painted.
