SOIL VAPOR EXTRACTION AND AIR SPARGE REMEDIATION SYSTEM

FORMER PETRO 220
2nd ST & BROADWELL AVE
GRAND ISLAND, NEBRASKA
NDEQ NO. UG# 120594-CT-1005
IIS# 59383

COVER SHEET
 SOIL VAPOR EXTRACTION AND AIR
 SPARGE REMEDIATION SYSTEM
 GRAND ISLAND, NEBRASKA

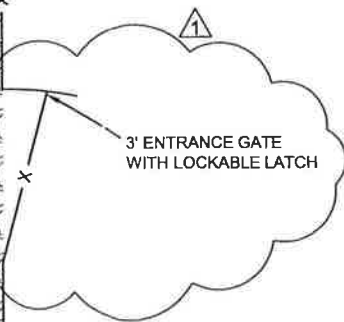
FENCE DETAIL
 NOT TO SCALE

NOTE: SEAL WOOD WITH CLEAR SEALANT.
